*Krystian SZEWCZYŃSKI, Mateusz BŁACH*

# **THE MOST COMMON DAMAGE TO THE FIRST GENERATION BOSCH UNIT INJECTORS**

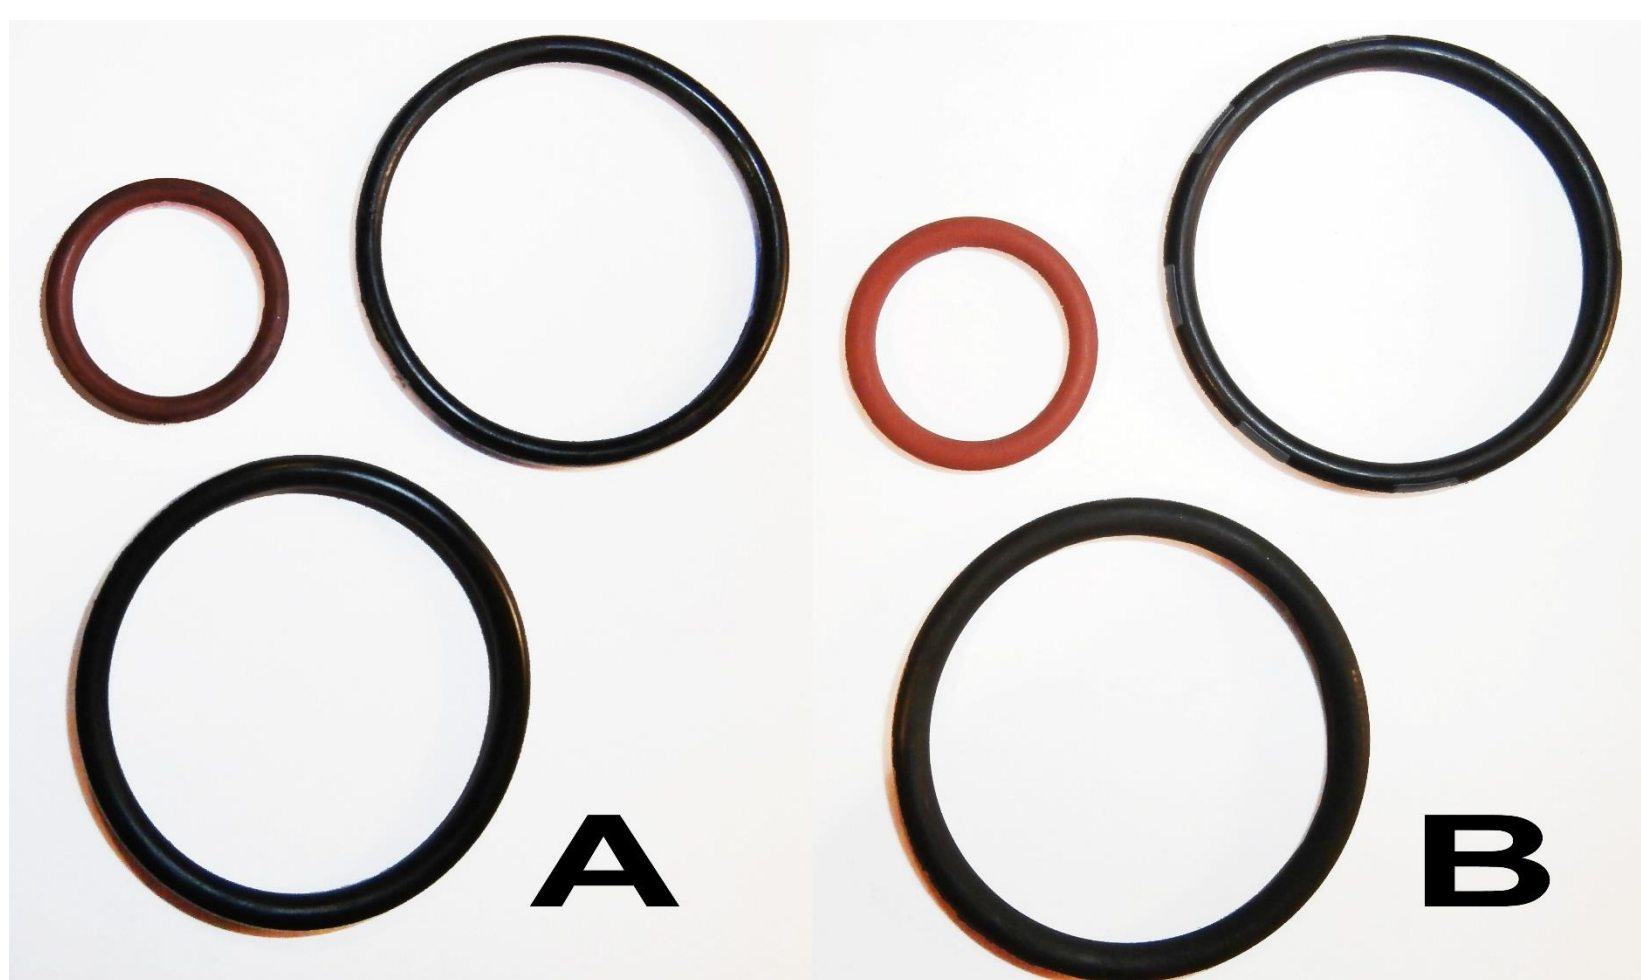
Unit injectors may be subject to wear as a result of standard operation as well as a result of mistake or oversight of the person providing maintenance. The most popular elements that are damaged include: seals, the injector's tip and the electric connector of the coil.

Fig. 2. External unit injector seals; A) old, B) new.

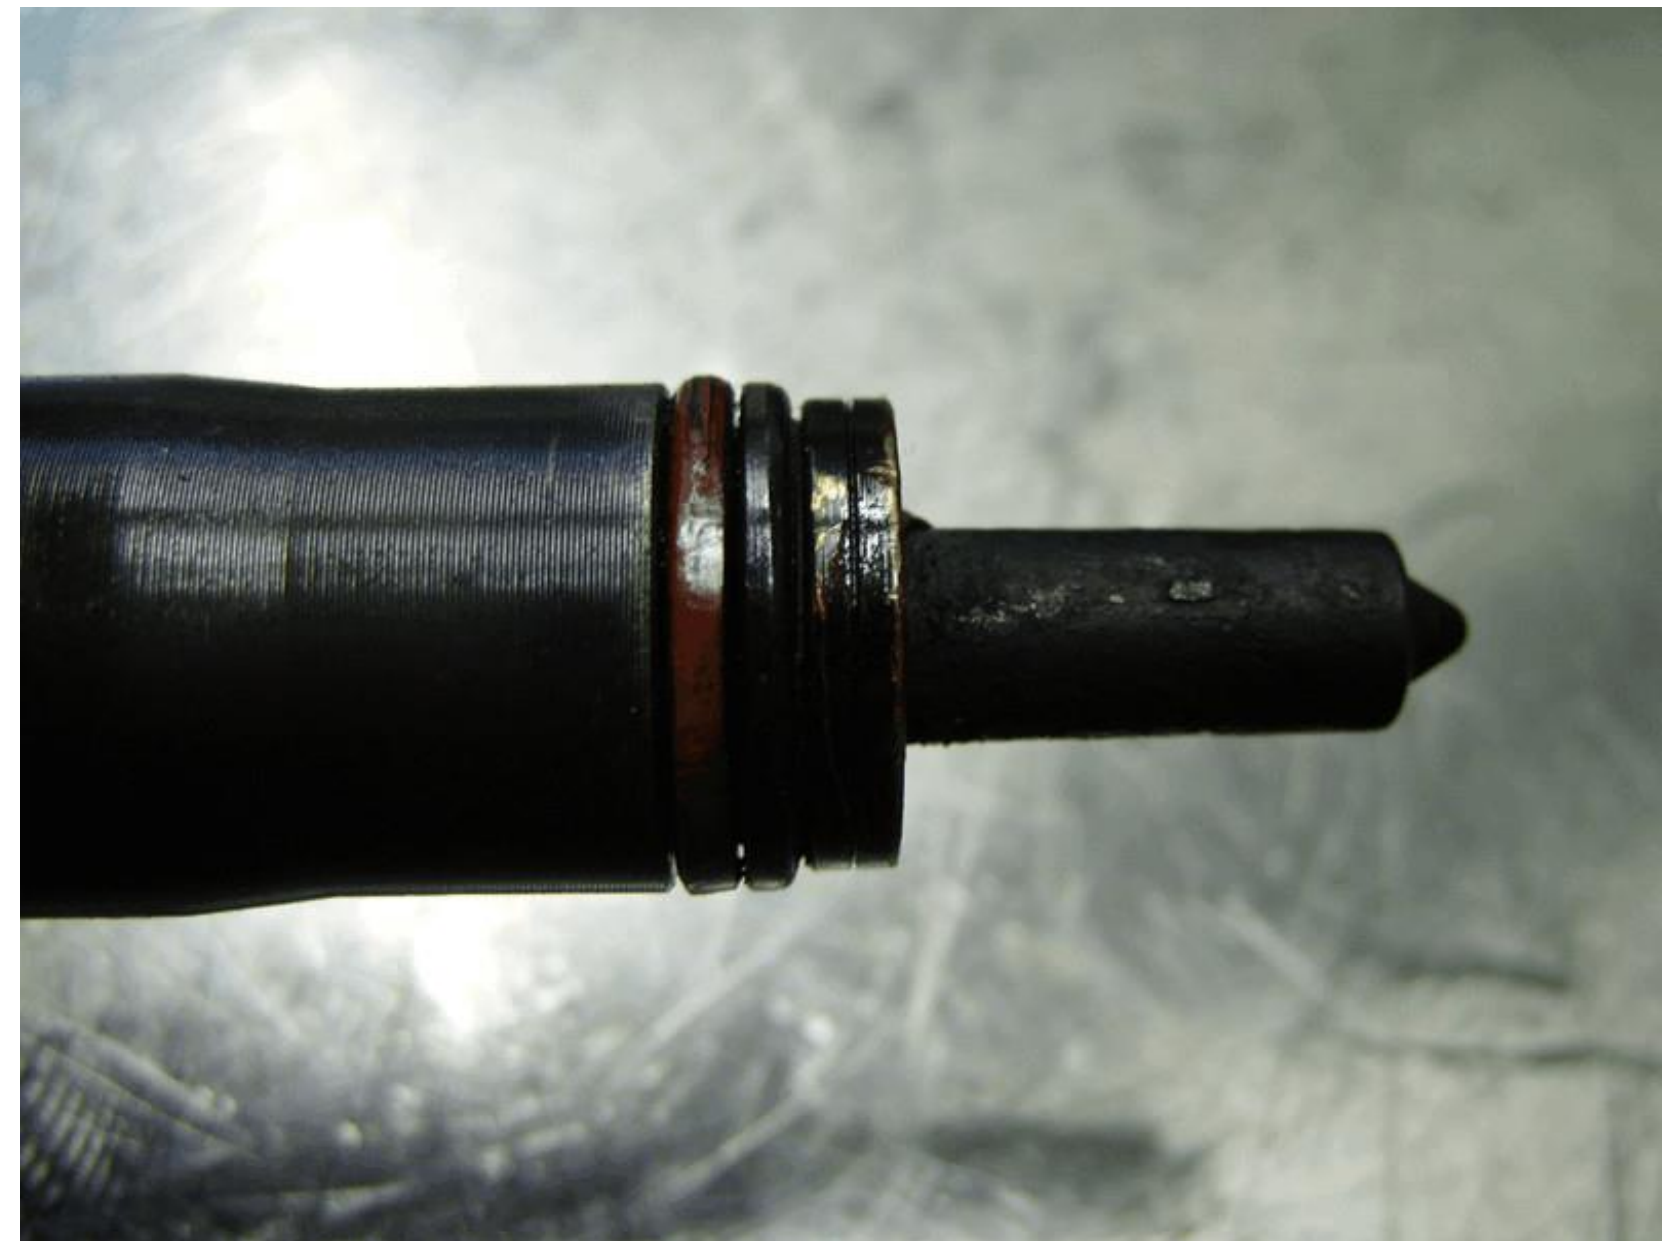
Fig. 3. Example of wear of the injector tip. [2]

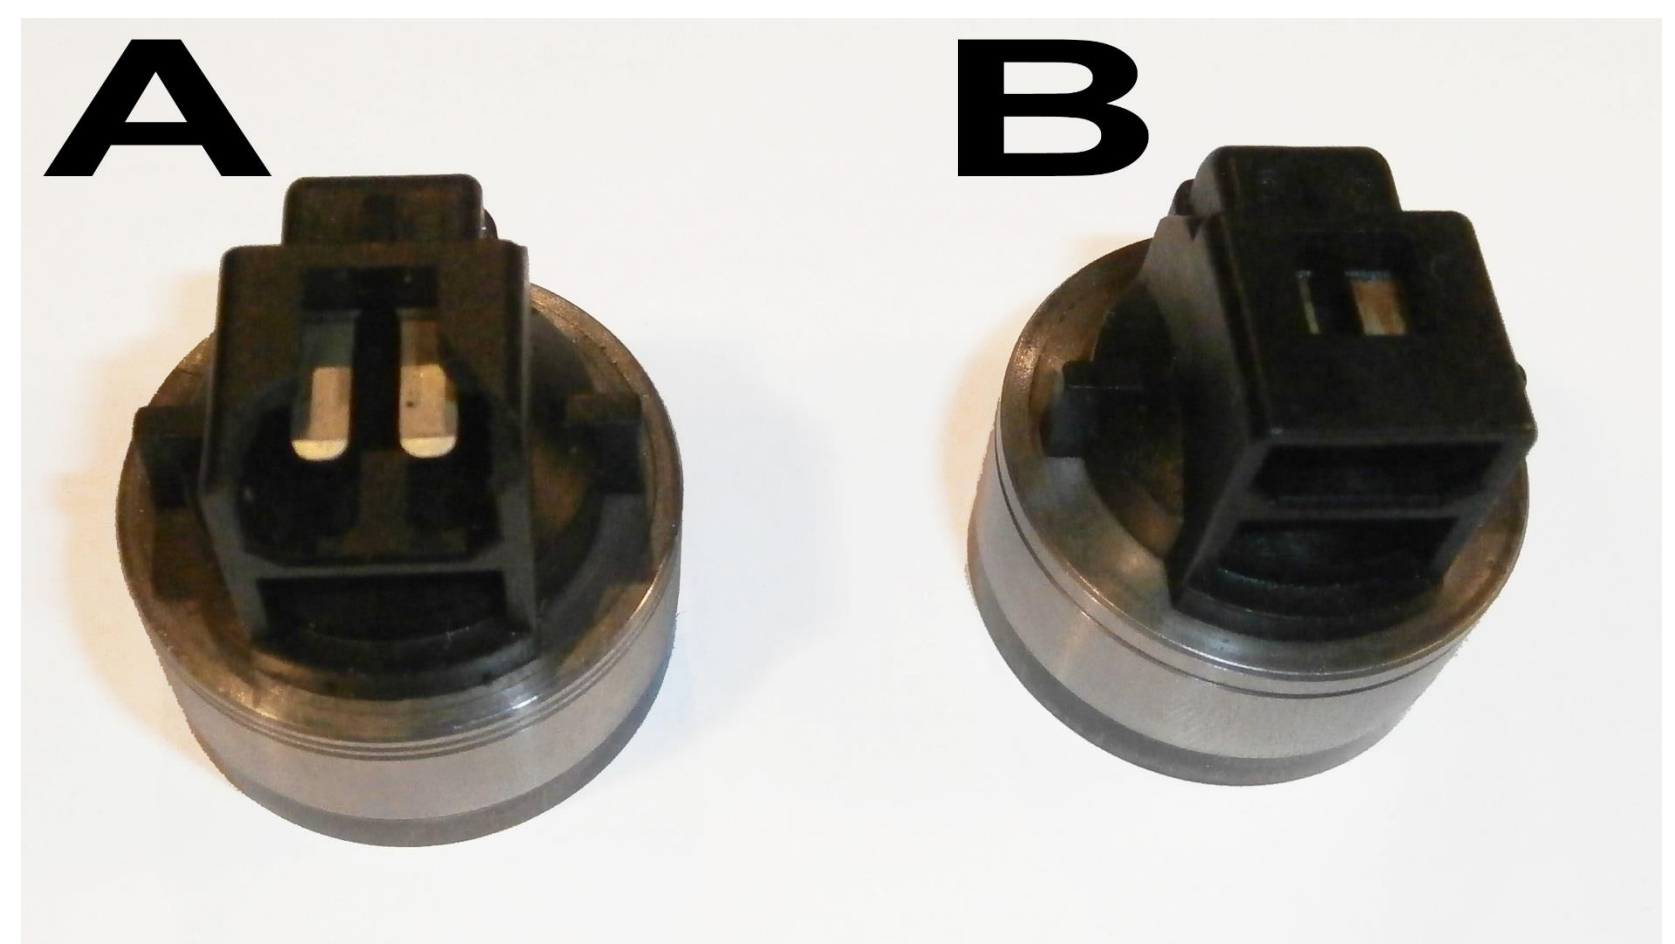
Fig. 4. Damaged (A) and undamaged (B) coil connector.
